Report of an  
Unidentified Aerial Phenomenon and its Safety Implications  
at O'Hare International Airport on November 7, 2006  
Case 18

Richard F. Haines, Ph.D. Senior Editor  
Chief Scientist

March 9, 2007

National Aviation Reporting Center on Anomalous Phenomena<sup>1</sup>

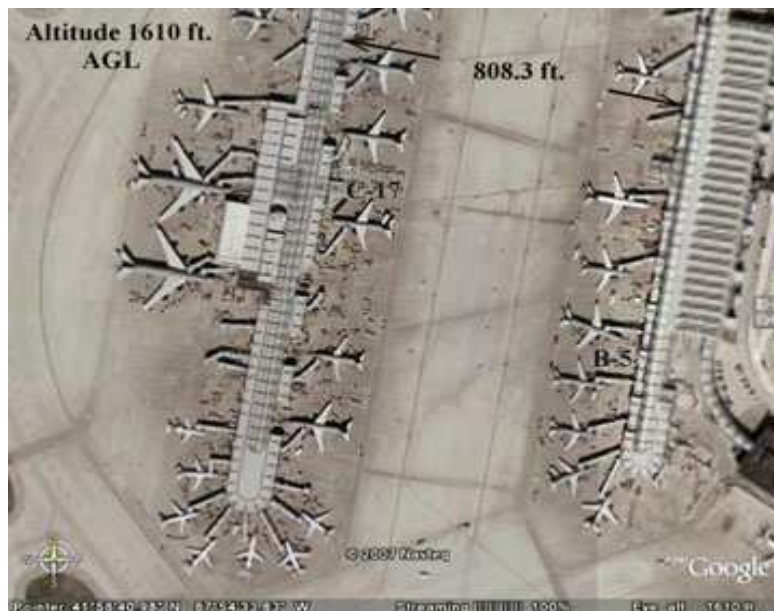
Figure 1. Aerial Photograph of United Concourses B and C from Altitude of 1,610 Feet.

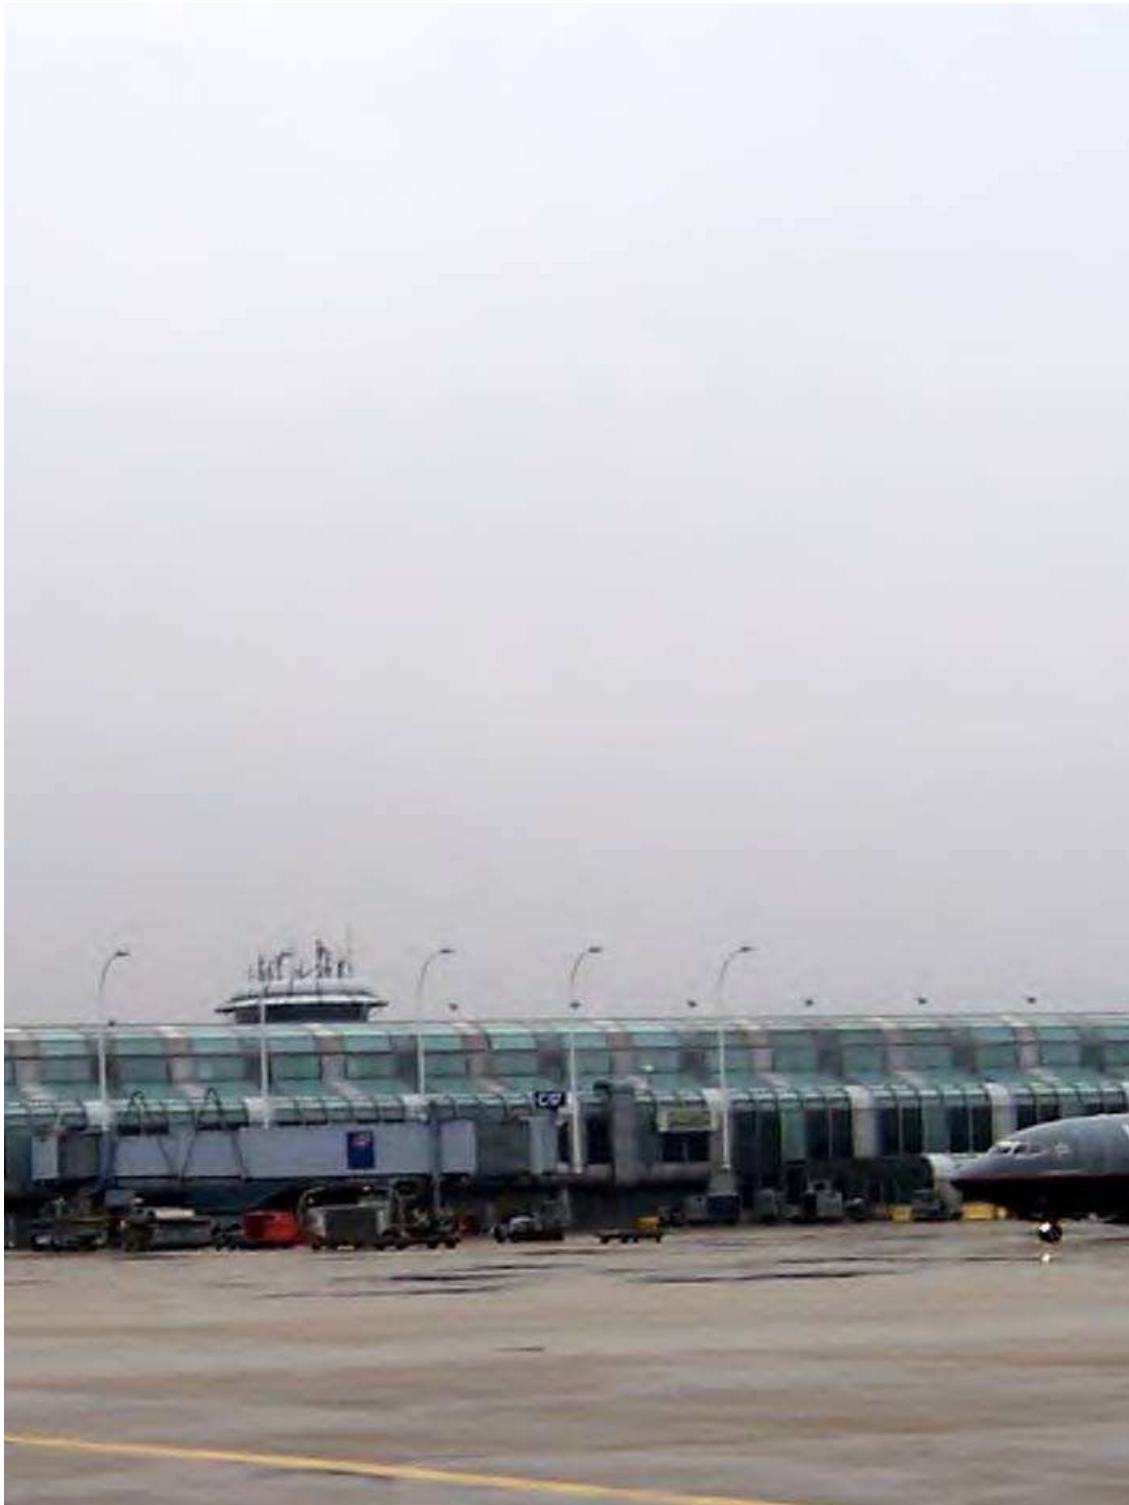
Figure 2. View of United Concourse C with Gate C17 Visible at Center  
(United Ramp Control Tower Seen on Roof at Left-Center)

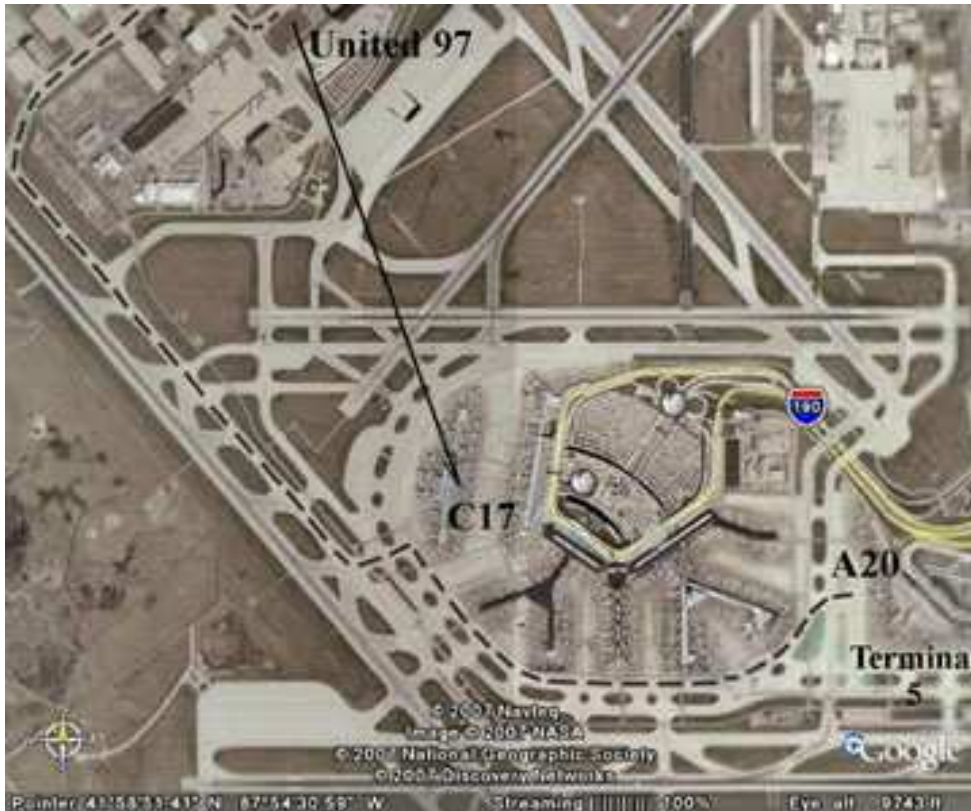
Figure 4. Aerial Photograph of Taxi Path of B-777

The dashed line in Figure 4 shows the taxi path of the empty jet taxied by witness B and C from A20 to the United maintenance hanger (labeled United 97)

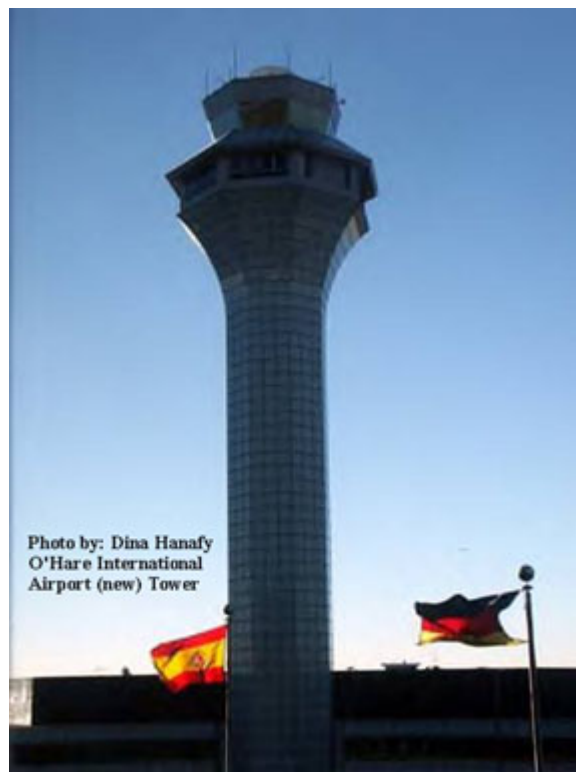
Figure 7. New O'Hare Airport Control Tower

The new control tower at O'Hare International Airport, completed in 1995, is 253 feet tall (905 feet MSL). It is shown in Figure 7. The ATC work area is at the level of the transparent outward sloping windows.

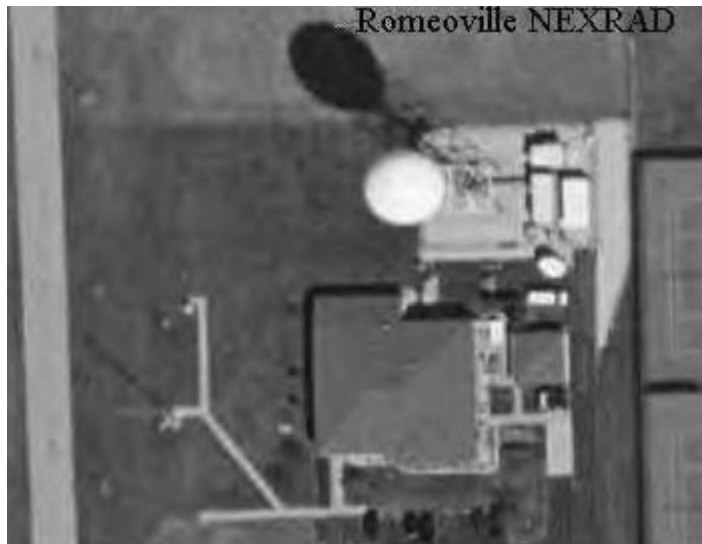
Figure 19. Aerial View of NEXRAD WSR-88D Weather Radar at Romeoville, Ill.

The nearest NEXRAD WSR-88D radar is at Romeoville, Illinois (Fig. 19).

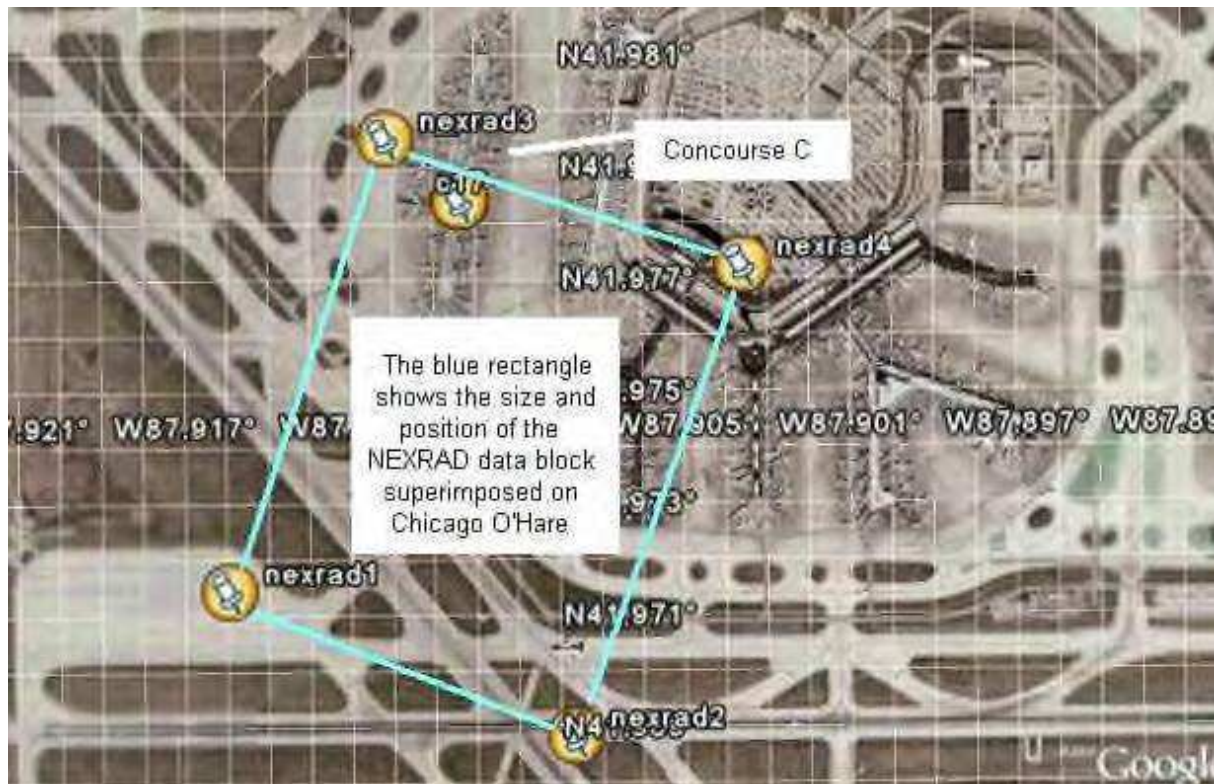
Figure 25. Footprint of the NEXRAD Radar Resolution Cell  
Superimposed on the Sighting Location  
(adapted from image supplied by James Smith)

The images show that Romeoville WSR-88D did detect some echo, at the average signal reflectivity level less than light precipitation, in the resolution cell corresponding to the sighting location above Gate C17 and at an altitude not inconsistent with the visual reports, at 1616 CST, and again at 1635 CST. The latter is within a few minutes of the estimated sighting time. However, the ground foot print of the resolution cell is rather large (Figure 25) and there are several possible interpretations for the echo, making this a result of limited value (see Section 6).

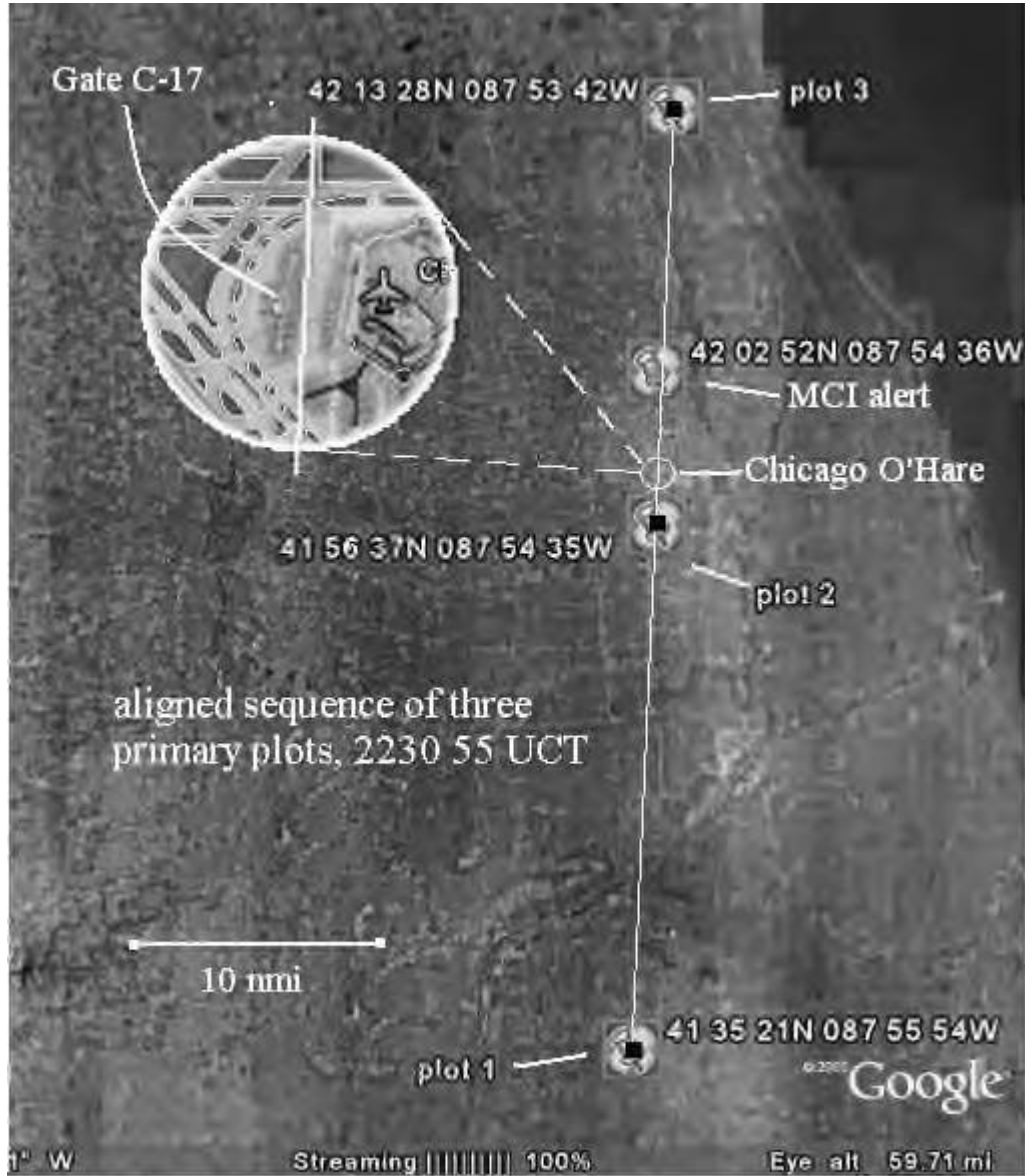
Fig. 30 Alignment of 3 Primary Radar Plots at 2230:55

The period symbol denotes "short run length primary tracks," and the capital "I" denotes an "MCI correlated track eligible for conflict alert." Reading from south to north, the coordinates define successive positions on a line that is for all practical purposes perfectly straight. A line ~ 43.8 miles long drawn between plots 1 and 3 passes through the coordinates of plot 2 within 350-400 feet. This line also passes about 200 ft to the east of the Chicago O'Hare Concourse C building. See Figure 30.

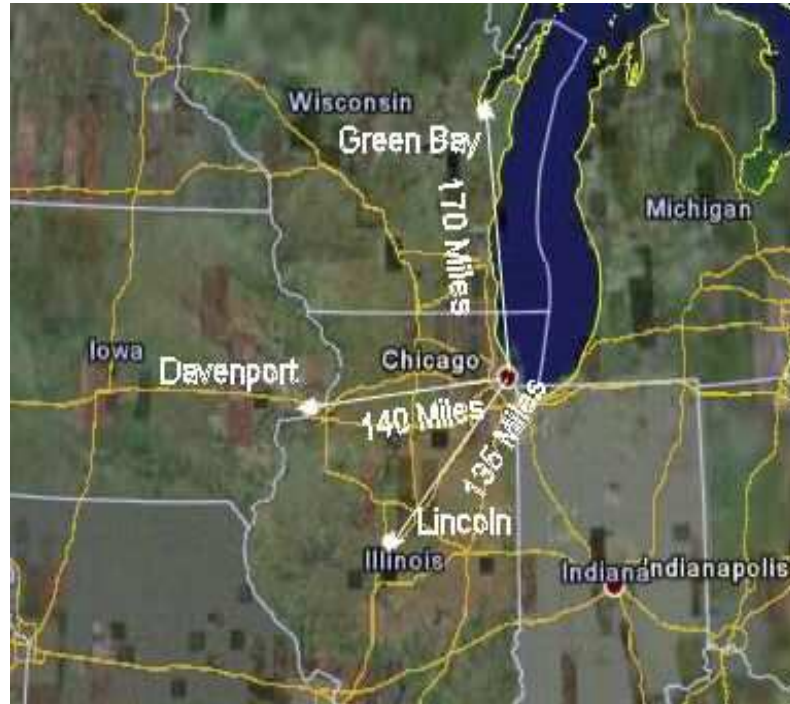
Figure 33. Map Showing Three Upper Air “Balloon Sites” Nearest O'Hare  
(The Most Representative Upper Air Site is Davenport, Iowa – 140 Miles Away)

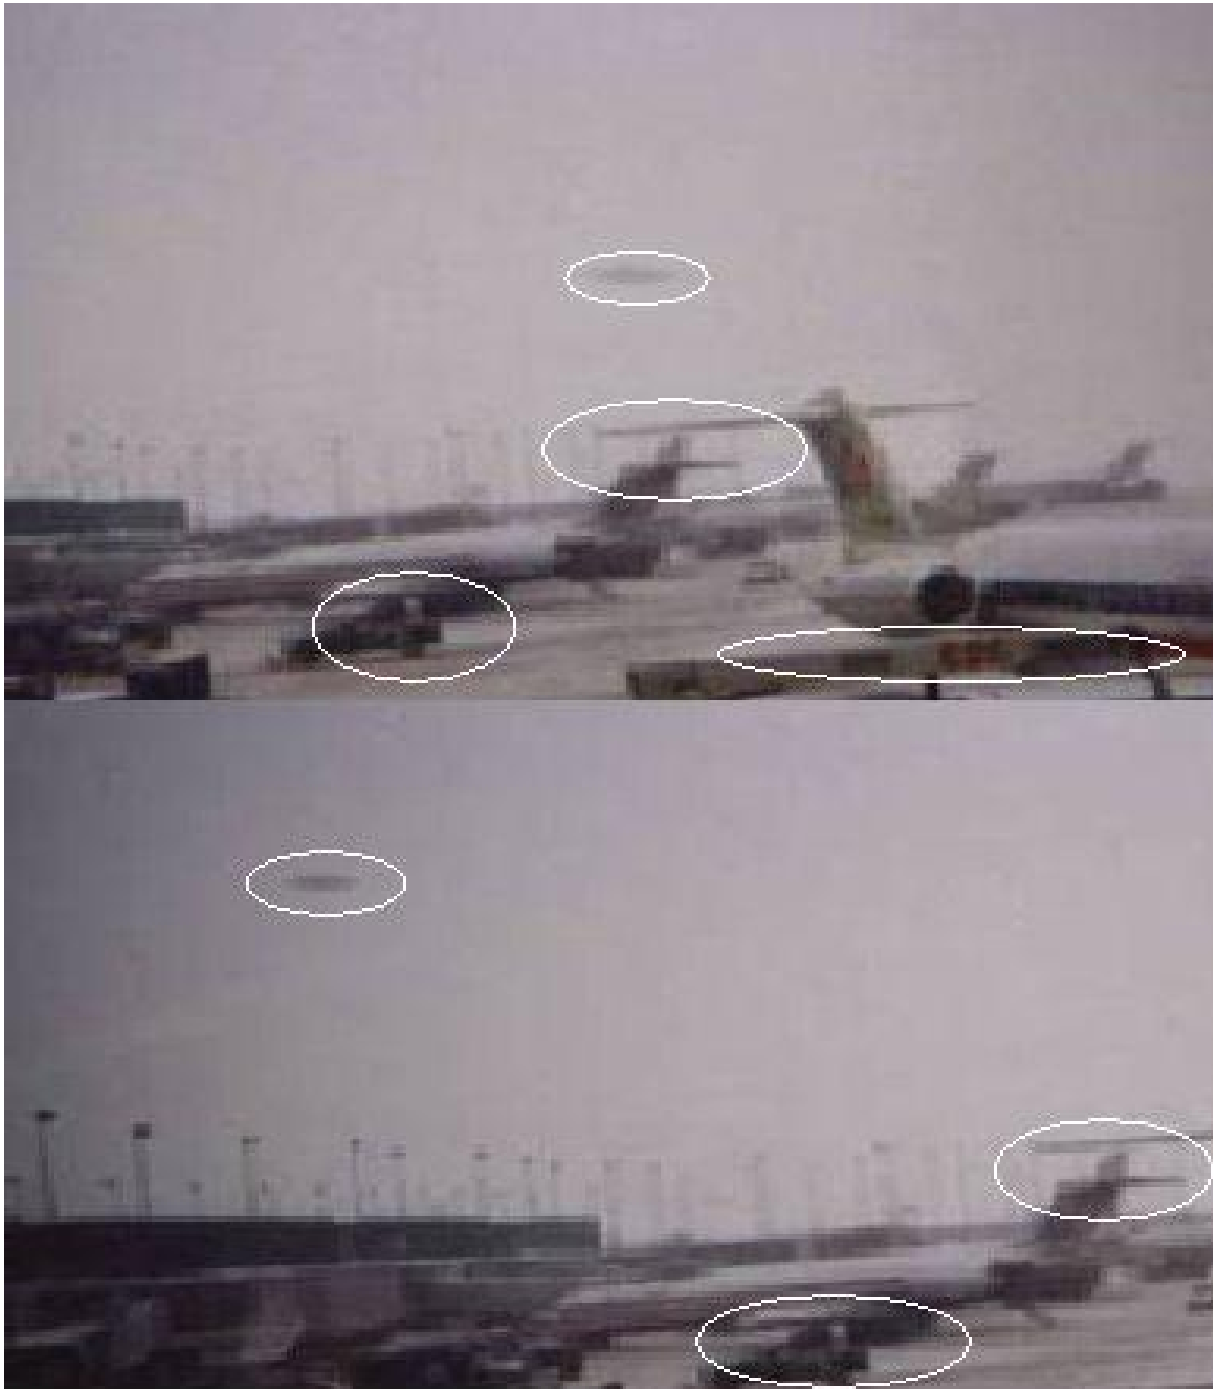
Figure 37. Hoaxed Photo at O'Hare

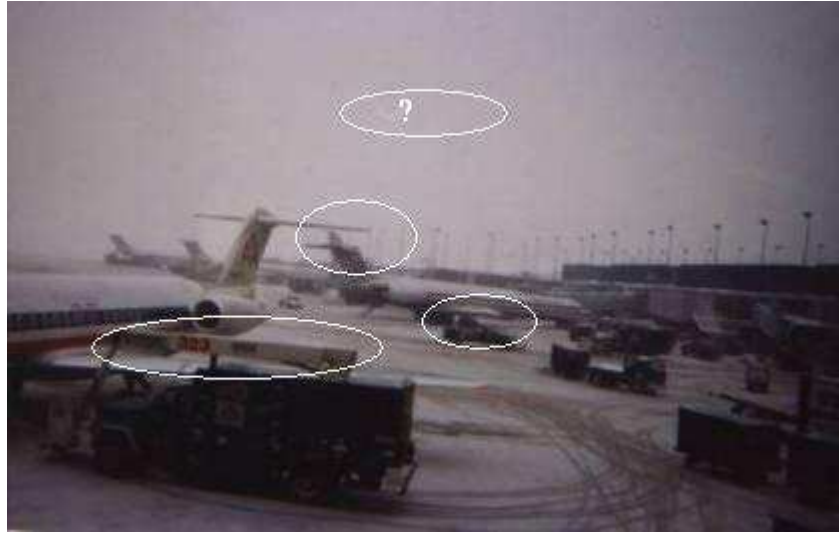
Figure 38. Original Photograph that was modified to create the Photographs in Fig. 37

Figure 38 shows the original source image.<sup>87</sup>
